ROOF/GUTTER REPORT

Site Address: 93-95 CASTELEREAGH STREET, LIVERPOOL NSW 2170

Instructions: Assess the condition of the roof, gutters and downpipes, and report any repairs required.

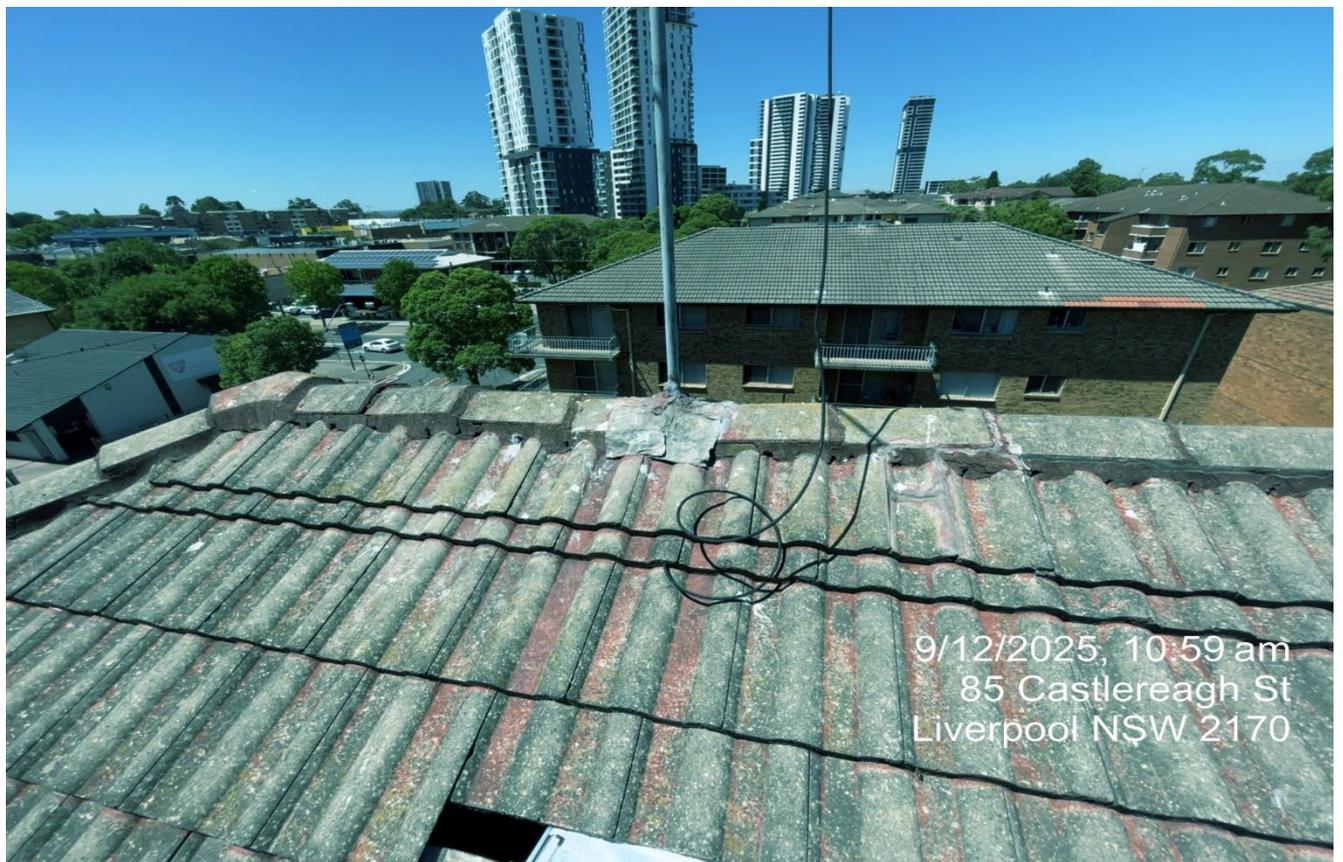
6. Valley clips should also be installed to secure valley cut tiles on both front valleys.
7. Mortar along all hips and the top ridge is in poor condition. All ridge and hip caps should be re-bedded/re-pointed to ensure the roof remains watertight in the long term.

1. Main top ridge and TV antenna pole penetration.

8. Flashing at the base of penetrations, incl the TV antenna and satellite dish, should be re-dressed & re-sealed.
9. Nine of the eleven flue/vent pipe penetrations need wired cowls installed to prevent birds nesting in the pipes.

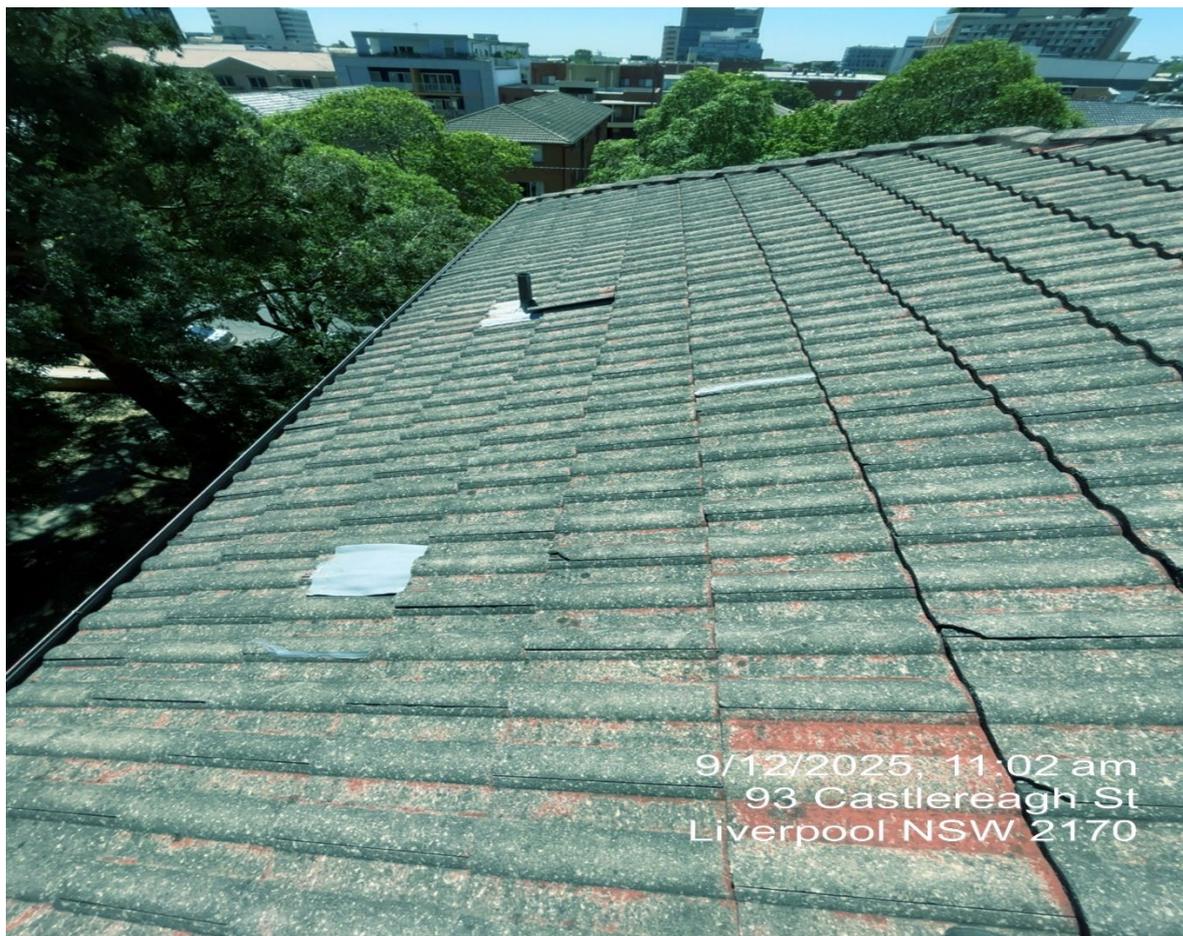
2. Although no obvious leak issues were detected, numerous broken roof tiles were found. A few had been sealed with silicone in the past, others had broken/missing corner pieces. Approx 20 roof tiles should be replaced.

2. View of broken and displaced roof tiles

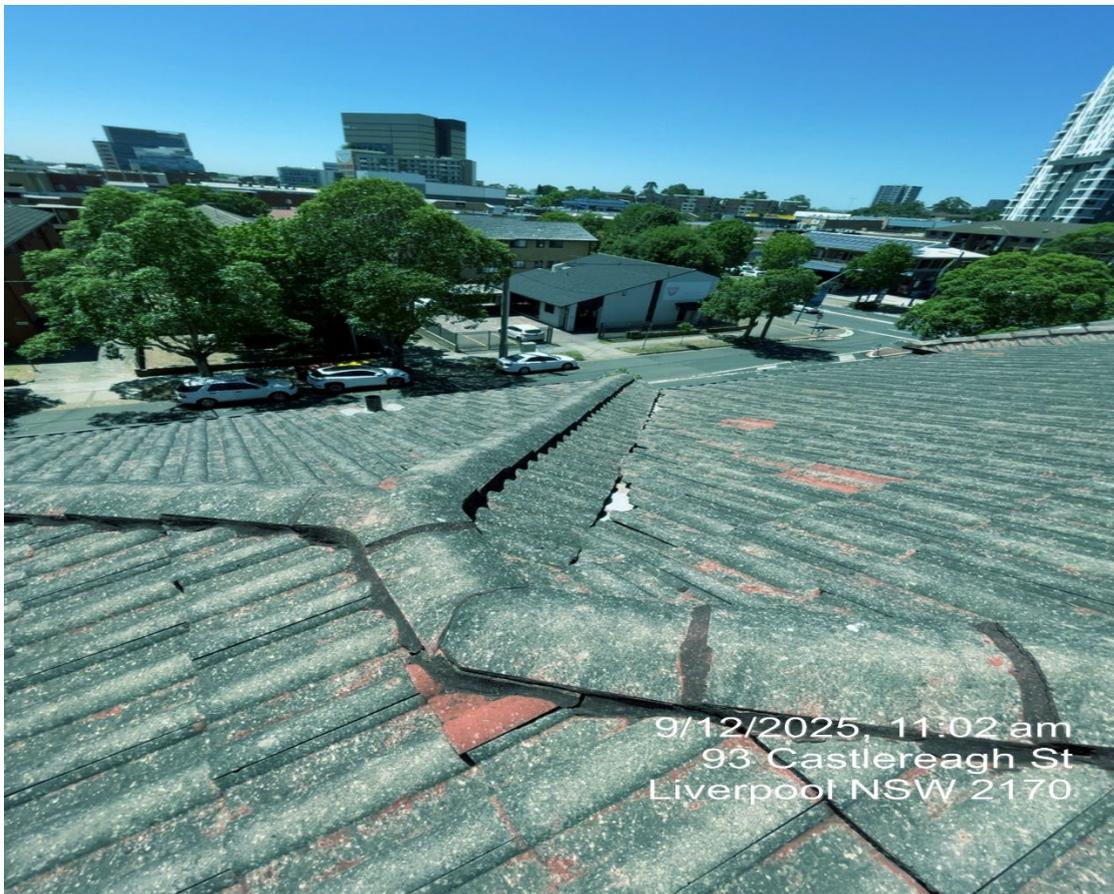
3. One broken hip cap should also be replaced (front elevation).
4. Numerous loose tiles across the roof should also be re-fixed.
5. Valley tiles on the front RHS valley are unprofessionally finished. All valley tiles should be removed and re-cut.

3. View of hip mortar and front valley tiles.

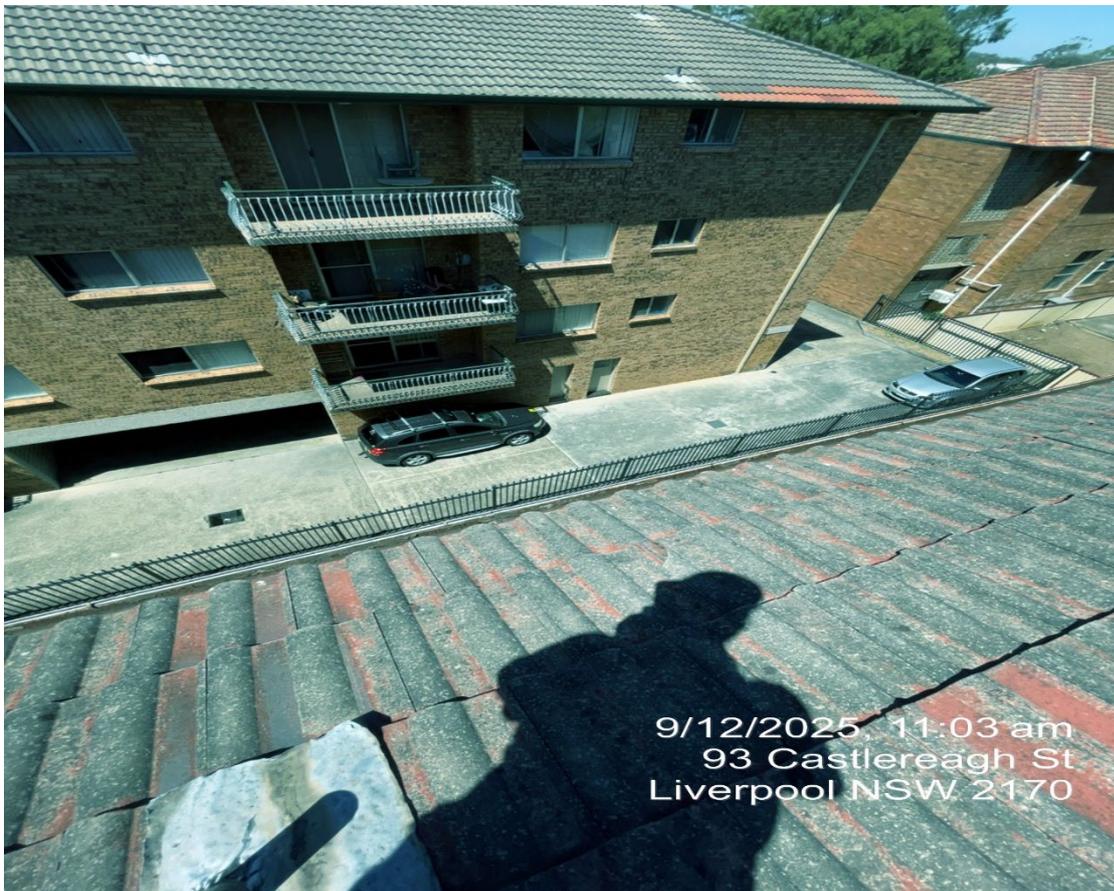
3. All gutters were clean (free of any blockages) at the time of inspection.
4. No leaking joins found; however several gutter sections are severely corroded (front & side elevations).

4. View of broken tile and corroded gutter.

1. Due to the extent of corrosion that exists, all eaves gutters should be replaced as soon as possible with new Colorbond components. Approx. 98Lm of new gutter will be needed. Due to the height factor, a boom or scissor lift will be required as a minimum safety measure – ie to comply with WHS Regulations.
2. All ten downpipes should also be replaced with new Colorbond downpipes (100 x 75) profile.
3. Consideration should also be given to connecting the four middle downpipes to the existing stormwater system.

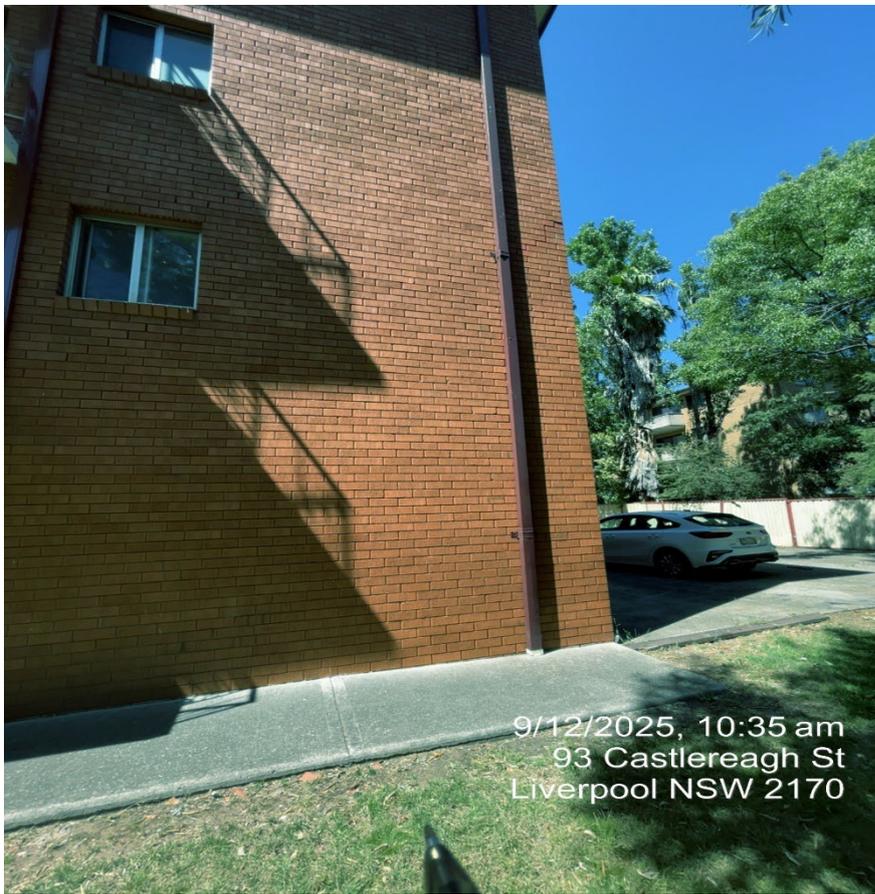
5. Ten downpipes exist. Six galvanised steel downpipes are original components. Two gal downpipes are located at the front of the building; two other gal downpipes are on the front LHS and RHS and two more are located on the rear LHS and rear RHS of the building. All are (100 x 75) profile and all are in fair condition.

5. Photo of original downpipe:

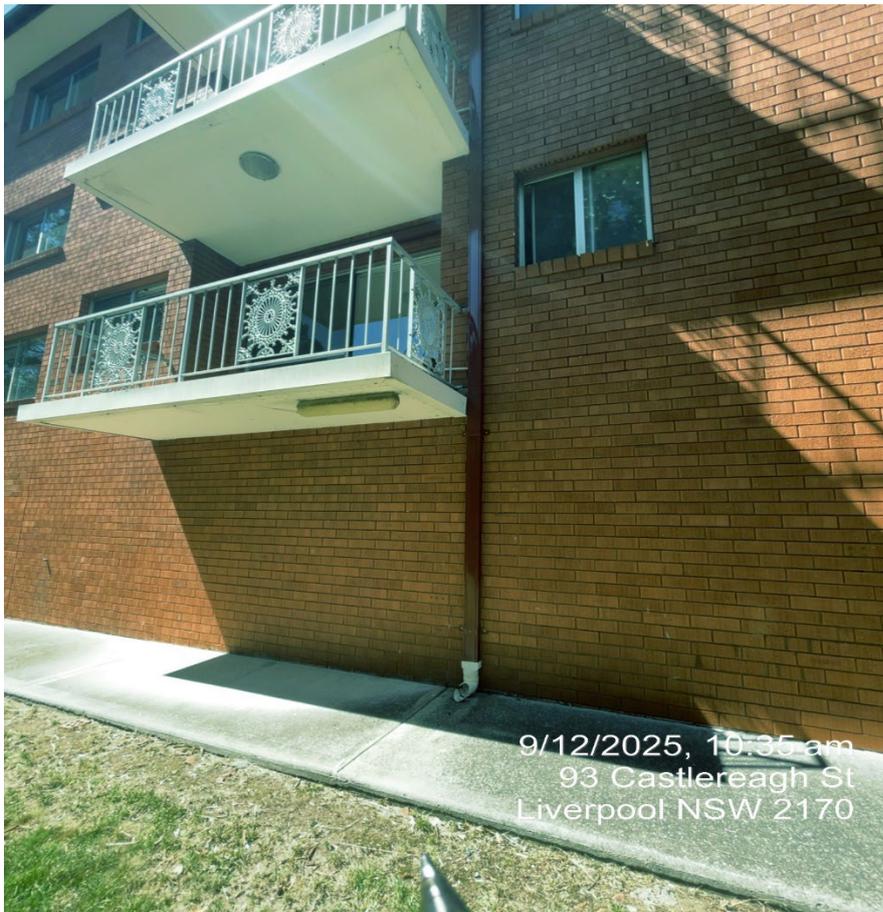
6. The remaining four downpipes (middle LHS and Middle RHS of the building) are in Colorbond material. All are (100 x 50) profile and all drain directly onto the ground – indicating all four middle downpipes have been added as an afterthought, to assist with roof drainage. All four Colorbond downpipes are in satisfactory condition, however the Colorbond material is incompatible with runoff from the Galvanised eaves gutters and as such, accelerated corrosion can be expected.

6. Photo of middle Colorbond downpipe (not connected to S/Water drain):
